Manhole Inspection Summary

Manhole # S57Q__003MH

Insp Date: **7/7/08 10:51 AM**

Location Address: **1413 haven st.**

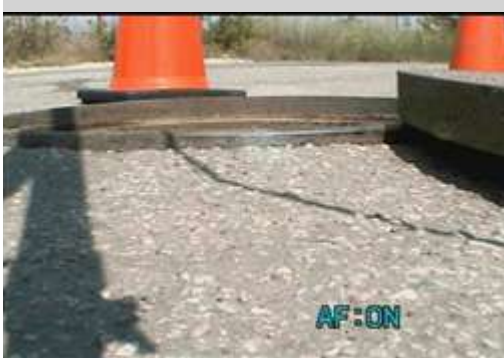
Miscellaneous

Diameter: **32** (in.) Length: **0** (in.) Dist A/B Grade: **1** (in.)

above grade

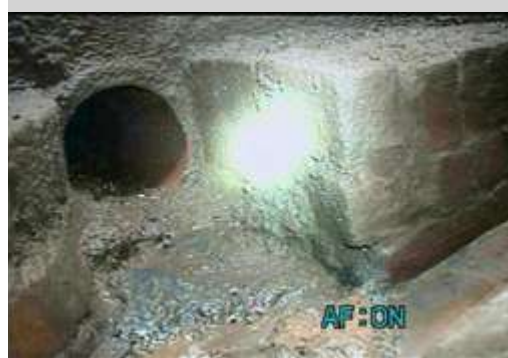
Defect 3

Condition: ☐ Sound ☐ Cracked ☐ Root Intrusion ☐ Deteriorated ☐ Leaks ☒ **Debris**

channel debris

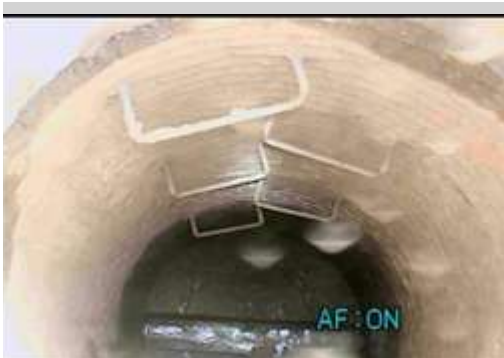
Defect 2

Count: **5** Missing: **0** ☒ **Corroded**

steps

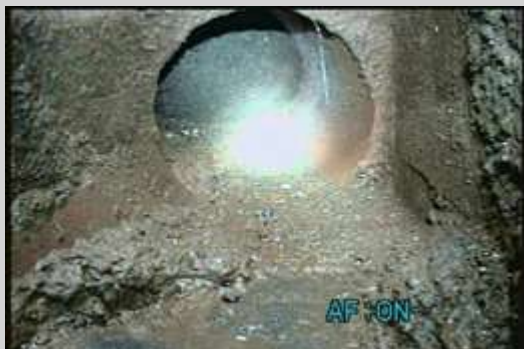
3 O'Clock Inflow

8 in. Circular Gravity Sewer
Pipe In @ 3 O'Clock

Deposits: ☐ None ☐ Mud ☐ Sludge ☒ **Debris** ☐ Grease

Silt Depth: 8 (in.) Deposits Extent: **Heavy**
